**TECHNICAL TIPS**

**Subject: SCU10, 12, and 13 Performance Labels**

### **Subject: SCU 10, 12 Refrigerant Orifices**

**Subject: SCU10, 12 & 13 SEER, PGE, & SHP Compressors**

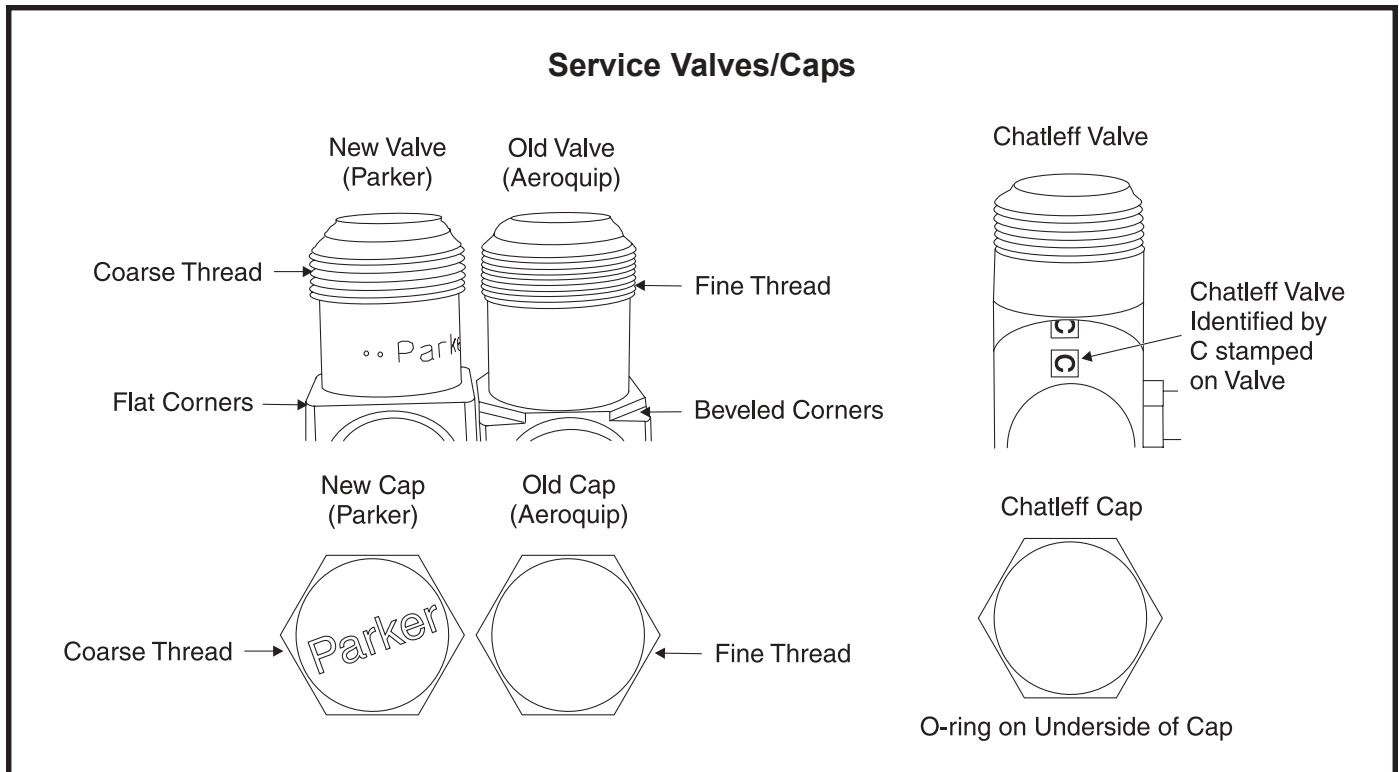
**DISCUSSION:** It has recently been determined that in some instances the caps of two valve suppliers (Aeroquip and Parker) may have become intermixed during production. A thread change was implemented on the caps of the service valves. A new coarse thread was used to standardize between the two valves. Product prior to the coarse thread introduction used a fine thread (see figure below). A third valve is also used, Chatleff, but it is not affected by this issue.

A fine thread cap will start on a coarse thread valve and a coarse thread cap will start on a fine thread valve. Although 1-2 turns may be achieved, they will not seat properly. Chatleff caps will only fit on the Chatleff valves, and Aeroquip and Parker caps will not fit Chatleff valves.

All valves now use the coarse thread cap and coarse thread valve. Suspect units have serial number dates codes 1602M, 1603A, 1603B, and 1603C. All inventory from 1603D and on have minimal, if any, occurrence.

**FIELD CORRECTIVE ACTION:** Replacement valve cap kits are available through Armstrong Technical Services. Kits contain 3/8", 3/4", and 7/8" coarse and fine thread caps. These kits will be provided on an "as needed" basis.

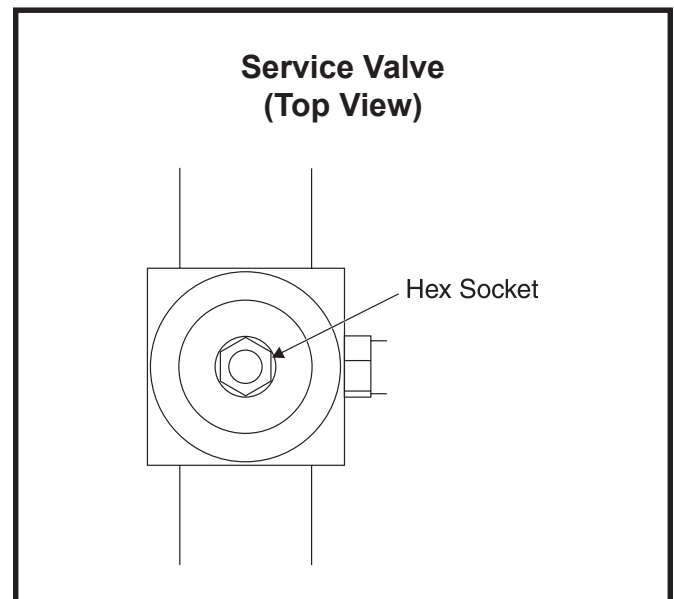
**DISCUSSION:** It has recently been determined that in some instances the service valves on the split system units may have been tightened beyond the specified settings. Generally it is the liquid line service valve (the smaller of the two) that is the more difficult valve to open. While occurrences have been low, we are providing a few valve opening guidelines in the event that a stuck valve should be encountered..

1. Make sure the hex wrench is completely inserted all the way to the bottom of the hex socket in the valve stem body (see figure below). Inserting the hex wrench only partially into the socket reduces the surface area that the wrench locks on to. The hex sockets in some of the sampled units were found to be slightly larger in the top 1/3 of the socket. Ensuring that the wrench is fully inserted and seated reduces the chances of the hex socket stripping while being opened.
2. Once the wrench is properly seated, use a backup wrench on the square valve body to secure the service valve while the hex socket is being turned.
3. If necessary, use a larger wrench on the hex wrench (such as an adjustable wrench, locking pliers, etc.) to gain more leverage when turning the hex wrench.

**FACTORY CORRECTIVE ACTION:** All inventory from 1603E and on are under strict calibration procedures. Liquid line valve (3/8") are torqued at 6-8 ft. lbs.; suction valves (3/4" and 7/8") are torqued at 18-20 ft. lbs.

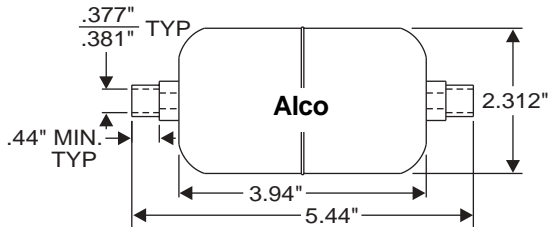
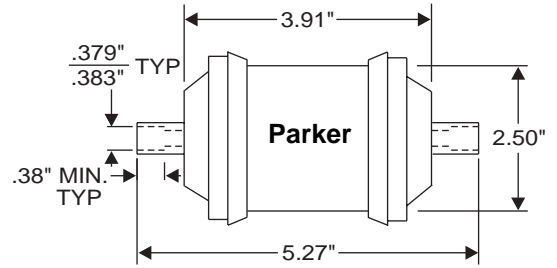
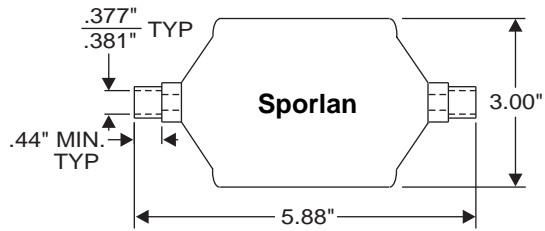
**Figure 1**

**Filter-Driers used in SHP and RH Heat Pumps  
Armstrong #43346-001**

Table 1 lists the filter-driers used on the Armstrong and Air Ease heat pumps and condensers and the Concord heat pump units. Figures 1 and 2 on page 2 show the different filter-driers used.

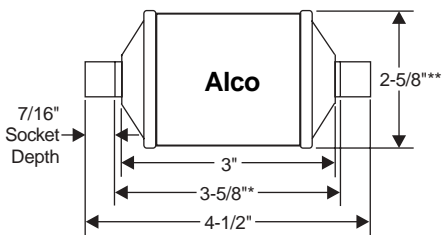
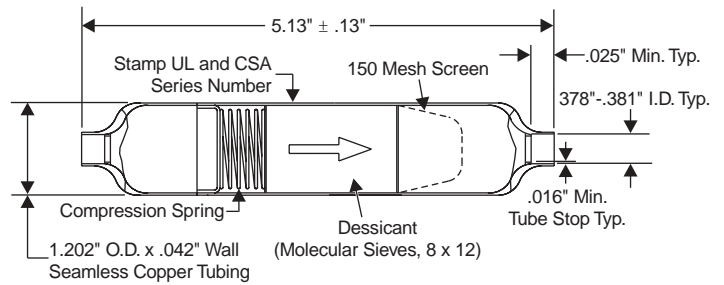
**Figure 2**

**Filter-Driers used in SCU Condensers**

**Armstrong  
#02974A002**

**Armstrong  
#40872-001**
