Troubleshooting Procedure

E11 – DC Motor Failure

501[11,12,21,22]1261 – GU26 501[11,12,21,22]1321 – GU32

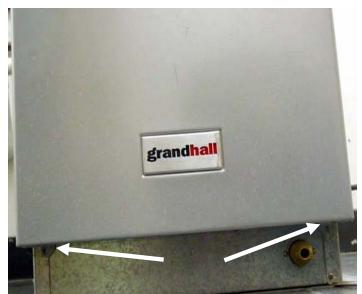
Remove Front Panel:

- a. Loosen two screws
- b. Push the front panel downward to remove

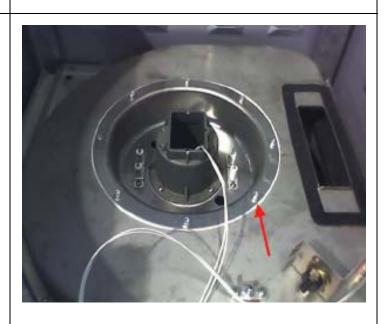
Gently remove the dual blower assembly; the injection blower is secured by silicone sealant so some force may be required
